**PETITION TO SET WATER LEVELS/MINIMUM FLOWS**

NAME OF WATER BODY: Montgomery Dam on the Megunticook River

LOCATION OF WATER BODY- TOWN(S): Camden

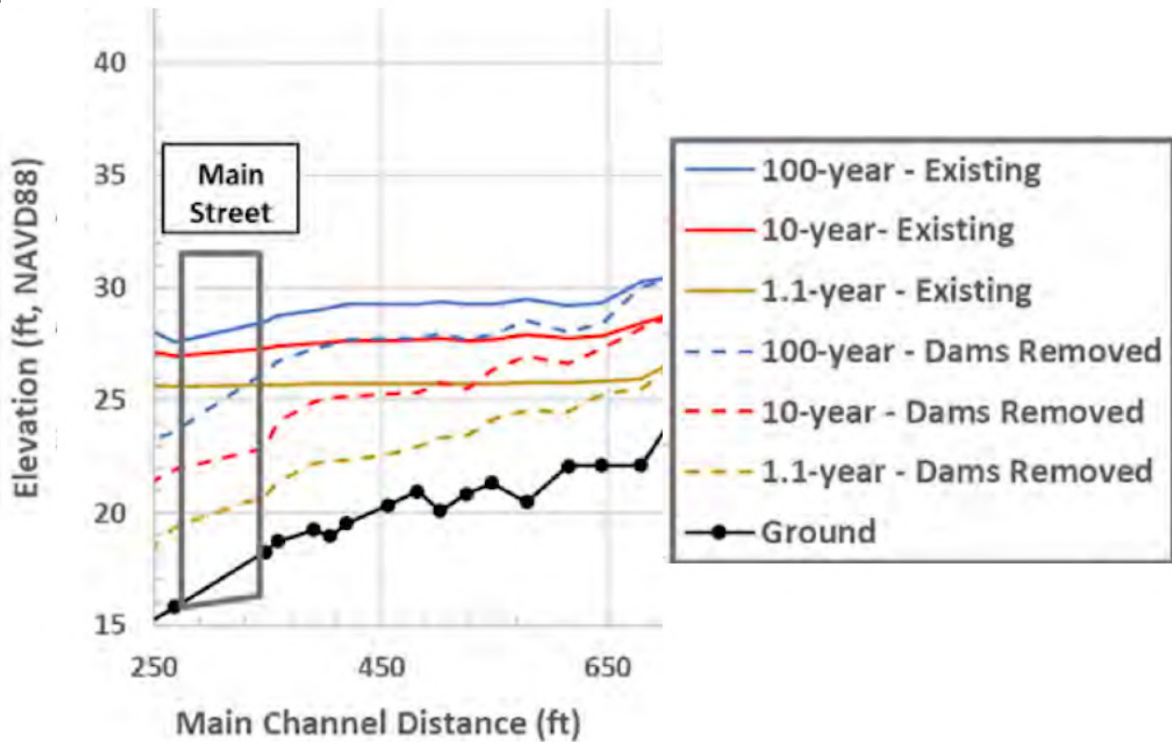
Graph caption: This graph from the joint InterFluve/Gartley & Dorsky report shows that the Montgomery Dam does not influence flooding profiles on Main Street in 100-year annual storm conditions, such as the one we experienced on 31 October of 2021. Main Street is elevated more than 5-feet above 100-year flood conditions.

the town sometimes communicates the message that the sluice gate must be opened for “flood control,” despite input from engineering experts, FEMA, and InterFluve to the contrary. For example, the FEMA 100-year storm flood map shows no overland flooding on Main Street. The joint InterFluve/Gartley & Dorsky 2021 report charts out flood profiles showing that there is no change in flood risk to Main Street in 100-year storm events with or without the dam present. Main Street is 7.5-8 feet above the spillway of the Montgomery Dam and because the dam is at least 23 feet above sea level, even the direst of sea level rise predictions from NOAA, at 10.5 feet, will have no effect on the Dam, or flooding risk of the Main Street businesses.

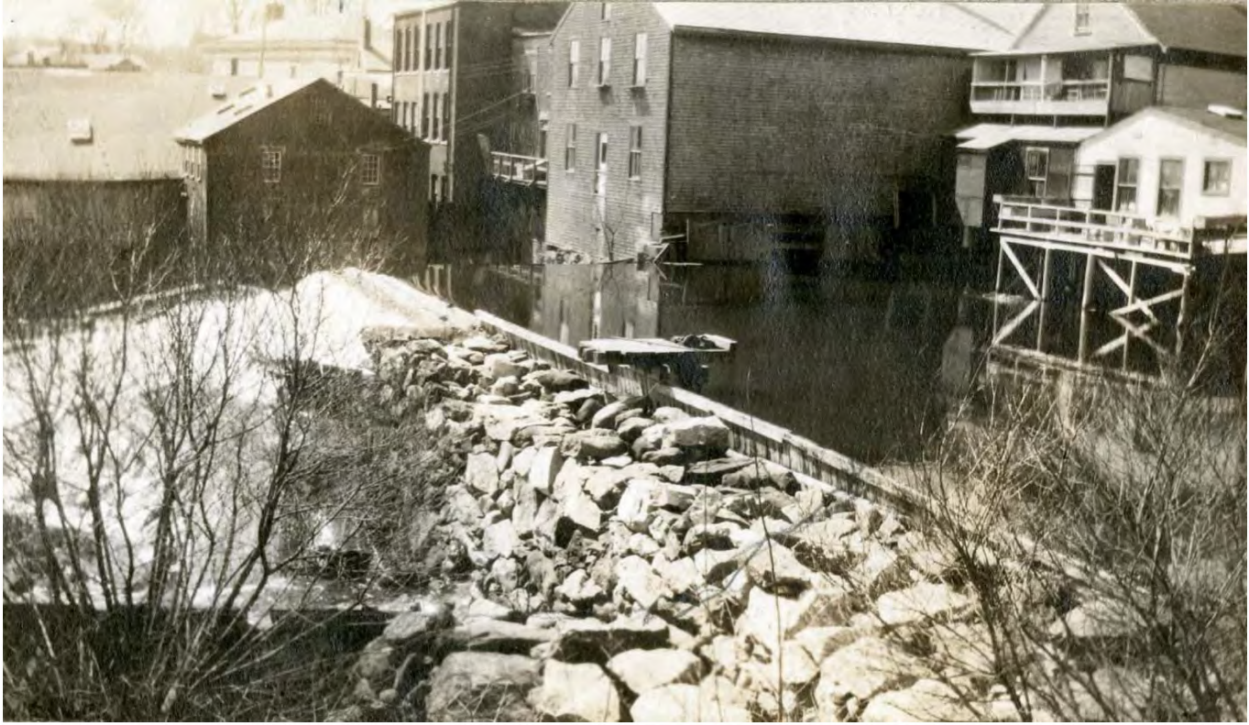
Historically, the water levels in the millpond were set to flow over the spillway. Here's a photograph taken in 1930 showing the current Main Street buildings on their piers in the millpond prior to the Olmsted Brothers' redesign. These buildings were designed to have the protective effect of slow moving, insulating water beneath their foundations. Camden's downtown was built around Montgomery Dam and the Megunticook as it is now. The buildings upstream of the impoundment were also designed with the protective, continual effect of the water on their foundations in mind.

Photo of pre-Olmsted construction, courtesy of the National Park Service, Olmsted Archives, Frederick Law Olmsted National Historic Site, Brookline, Massachusetts.

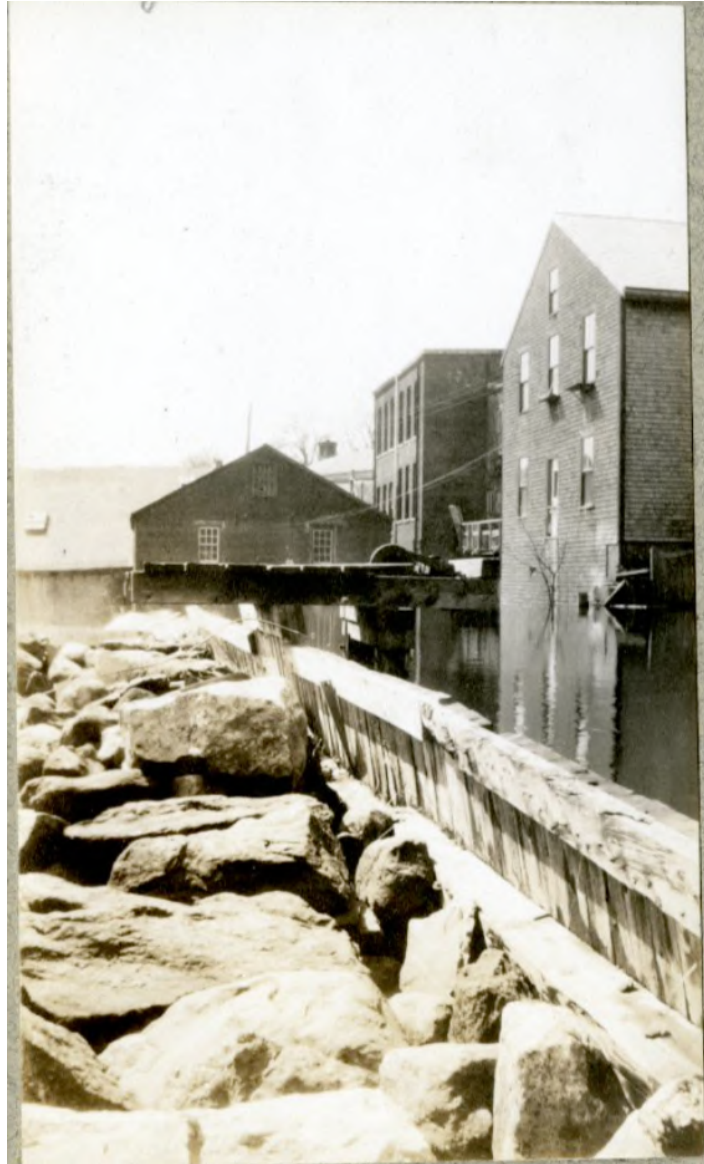
Image showing some of the original Main Street buildings (Village Shop, Marriner's, Once a Tree, etc) as being built on the millpond prior to Olmsted's redesign of the millpond and waterfall. Image is courtesy of Walter Clarke, May 1930, Olmsted Archives, Frederick Law Olmsted National Historic Site, Brookline, Massachusetts.

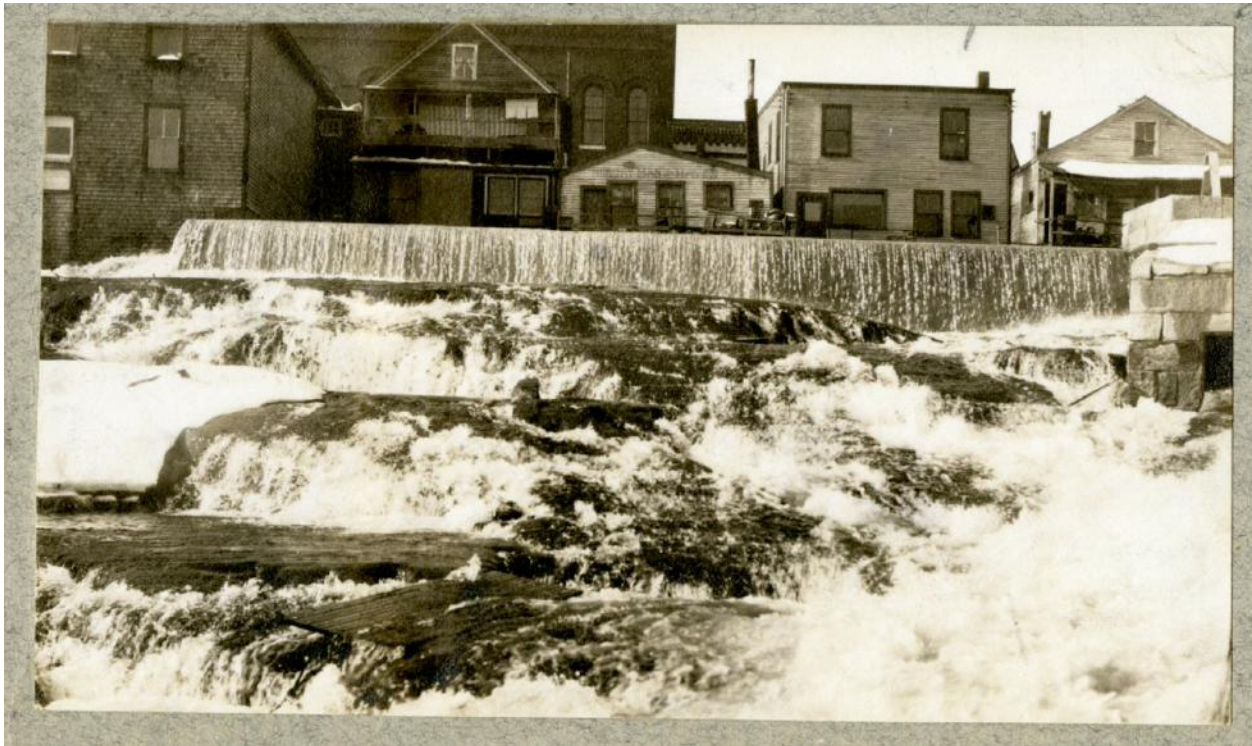
Original design by Olmsted showing the infinity pool spillway of Montgomery Dam (then called the Camden Shore Front Project) where the water level was set at 23.66 feet above sea level. Photo by Walter Clarke, January, 1931 courtesy of the National Park Service, Olmsted Archives, Frederick Law Olmsted National Historic Site, Brookline, Massachusetts.

During the 1930s the Montgomery Dam was redesigned by Frederick Law Olmsted, Jr., to be a spectacular 100-foot infinity pool, 75-feet on the East side and 25-feet on the South side. Since the 1930s, when the millpond and falls were designed, the water has flowed at this level. The original design below from the Olmsted Brothers firm shows the water level set at the spillway. In addition, the InterFluve/Gartley & Dorsky report states, "Normal pool elevation at spillway crest." The Maine Emergency Management Agency (MEMA) notes in their 2019 report of the Montgomery Dam that, "the water level is maintained with water over the spillway year round."

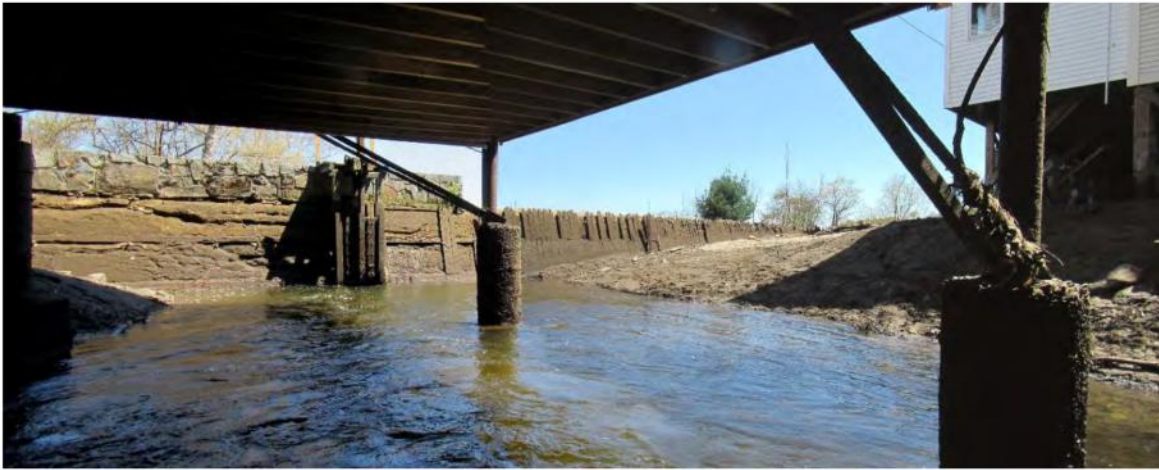
The low-level outlet located in the left abutment is controlled by a vertical gate (Figure 21). The gate is operable (2018) and is used to draw down the impoundment as needed for maintenance [...]. Under normal conditions, it is left in the closed position.

**Figure 21. View of lower impoundment in drawn down condition, May 8, 2018. Non-overflow portion of dam and headgate at left half of image, spillway at right half of image. Normal pool elevation at spillway crest.**

In 2019 InterFluve and local engineering firm Gartley & Dorsky described the sluice gate as operable and normally being left in the closed position. Furthermore they describe the normal pool elevation at the spillway crest. The following is a section from page 26 of the May 2019 report that details this:

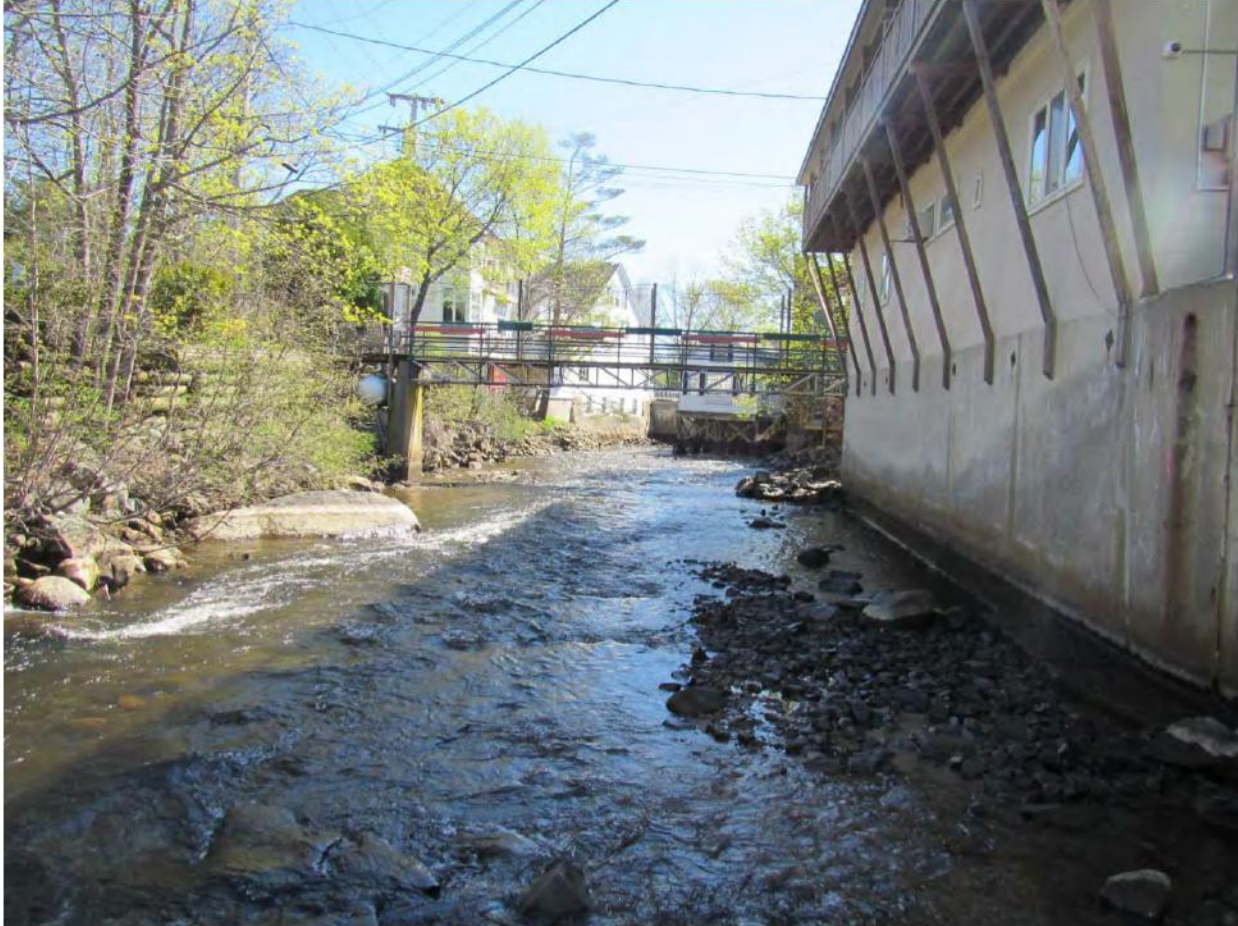
Behind the Montgomery Dam the millpond is approximately 50 feet by 100 feet, however, the impoundment extends beneath the businesses and under Main Street to a point approximately 350 feet upstream of Main Street or 525 feet upstream of the dam. Here's a photograph from page 27 of the 2019 joint InterFluve/Gartley & Dorsky report that shows the upstream impoundment in a drawn down condition. The normal water level can be seen on the building face and on the boulder. Recently the upstream impoundment has been drawn down due to the open sluice gate.

*Figure 22. View of upper impoundment looking downstream from Brewster building in drawn down condition, May 8, 2018. Stain lines on large boulder at left, and concrete wall at right indicate normal pool elevation. The ground to the left of the channel is comprised of urban fill.*

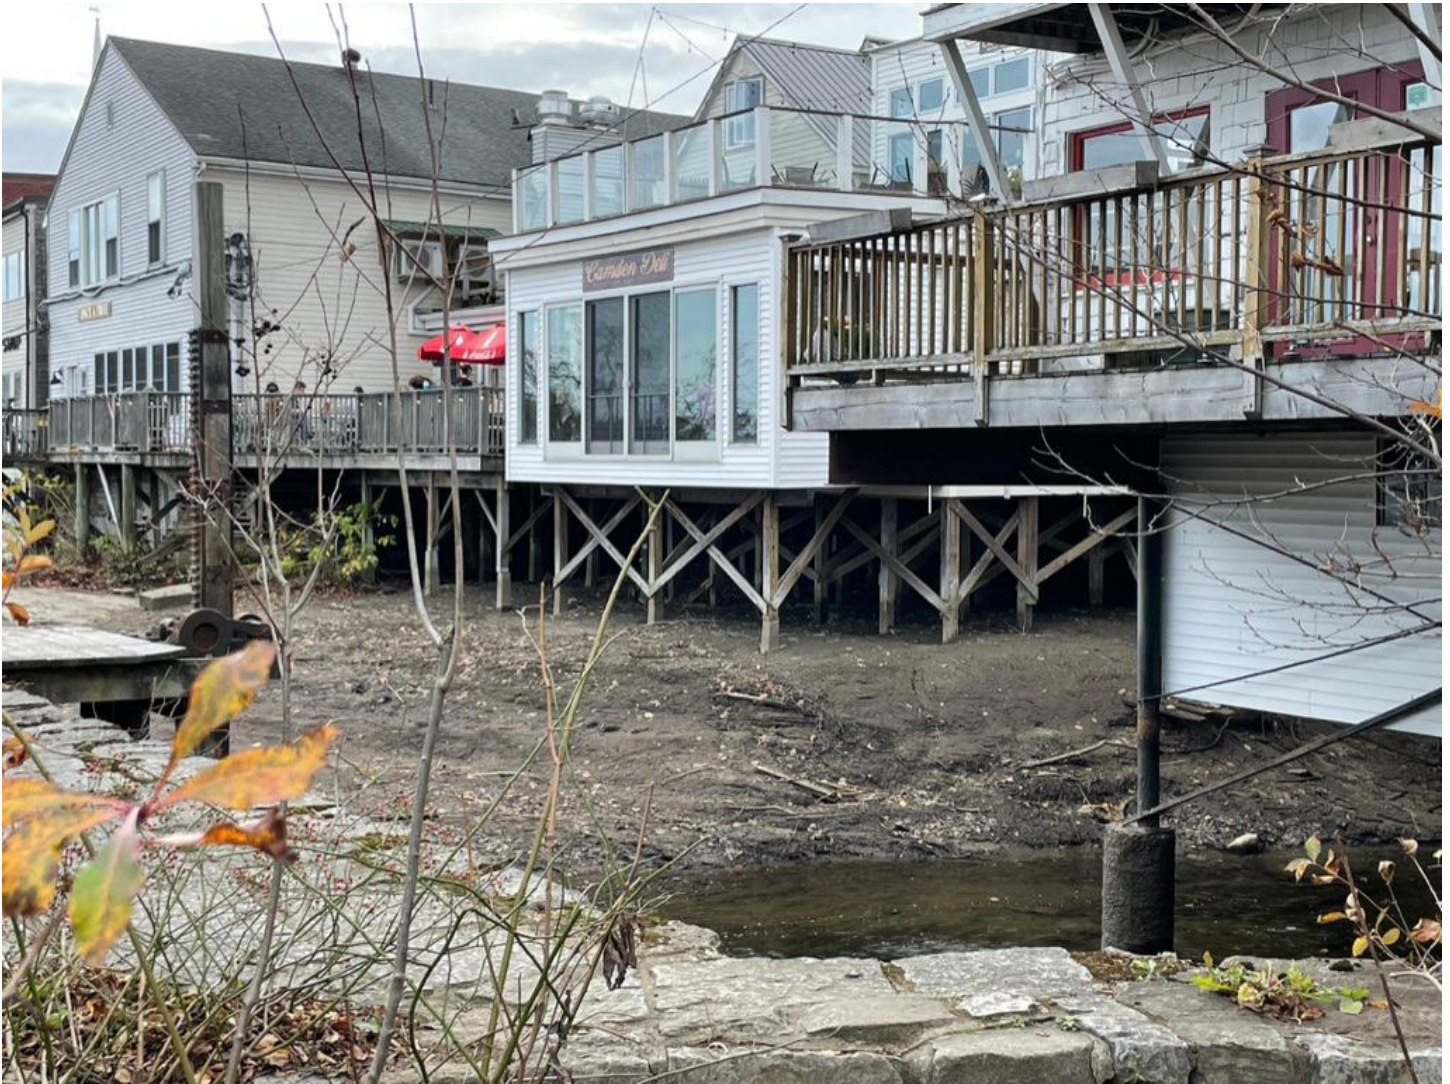
**Addendum D: Our Building Underpinnings Exposed to Frost, Scour, Erosion, and Structural Concerns**  
**Photo taken: November 2022**

**When the millpond is emptied and remains empty due to the open sluice gate, the sediment pattern beneath our building foundations is altered causing erosion, scour, and frost, putting our piers and building investments at increased risk. In addition, this is not the condition under which we purchased our businesses and buildings and does not deliver the view we have promised customers for nearly a century.**

We propose that the water is set to traditionally observed levels as documented on the designer’s plans for Montgomery Dam and confirmed by the joint InterFluve/Gartley & Dorsky report and the 2019 MEMA inspection report to, “water over the spillway year round.” This is the height of the water around which the downtown was built and has been confirmed to be suitable for 100-year storm events.

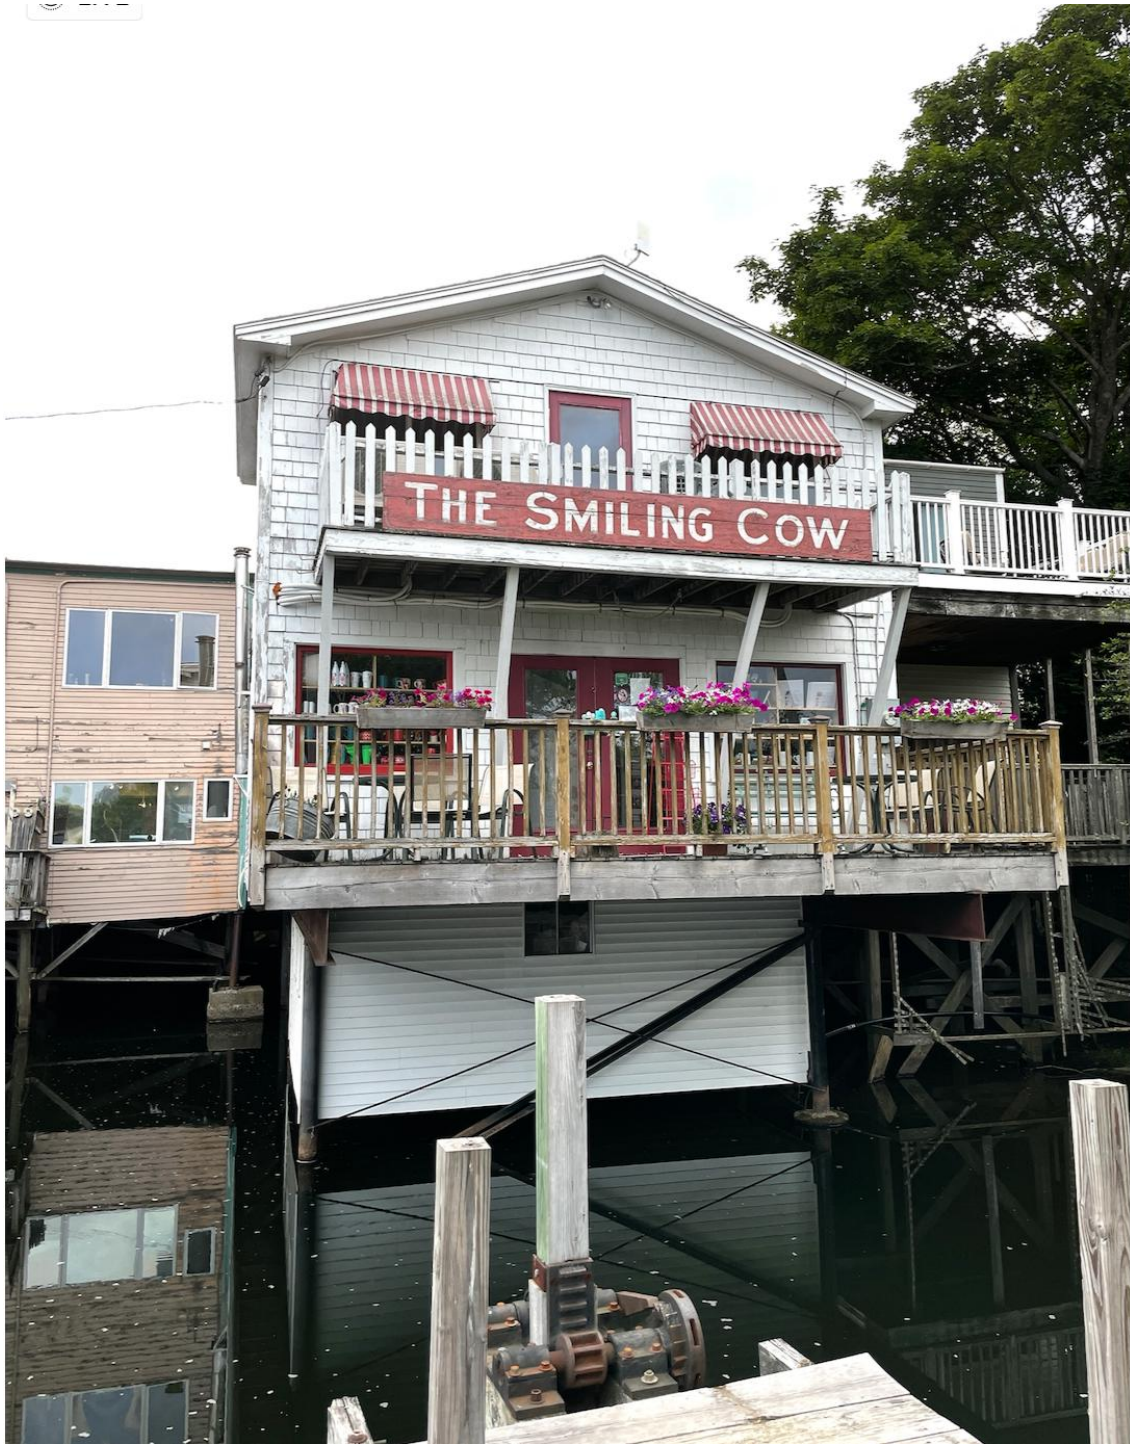
**Photo showing the normal millpond level maintained at “over spillway year round” from July 2021 and the false bottom or apron of the Smiling Cow.**

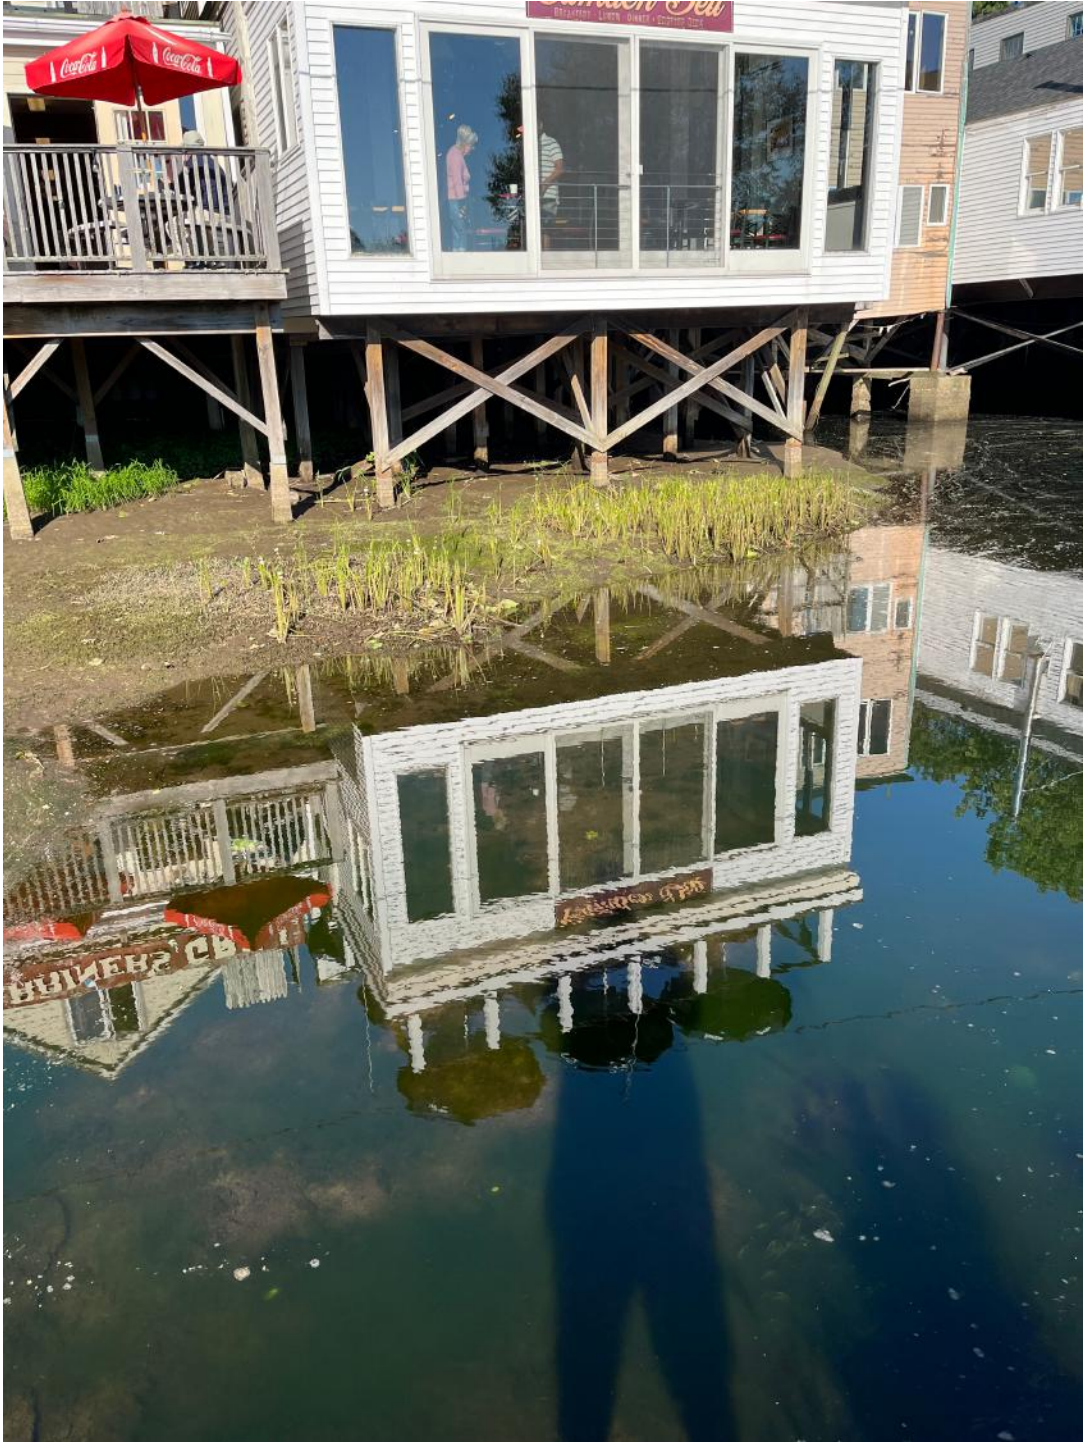
**Cattails beginning to grow up and algal blooms in the millpond with the sluice gate open. Photo taken August 2022**

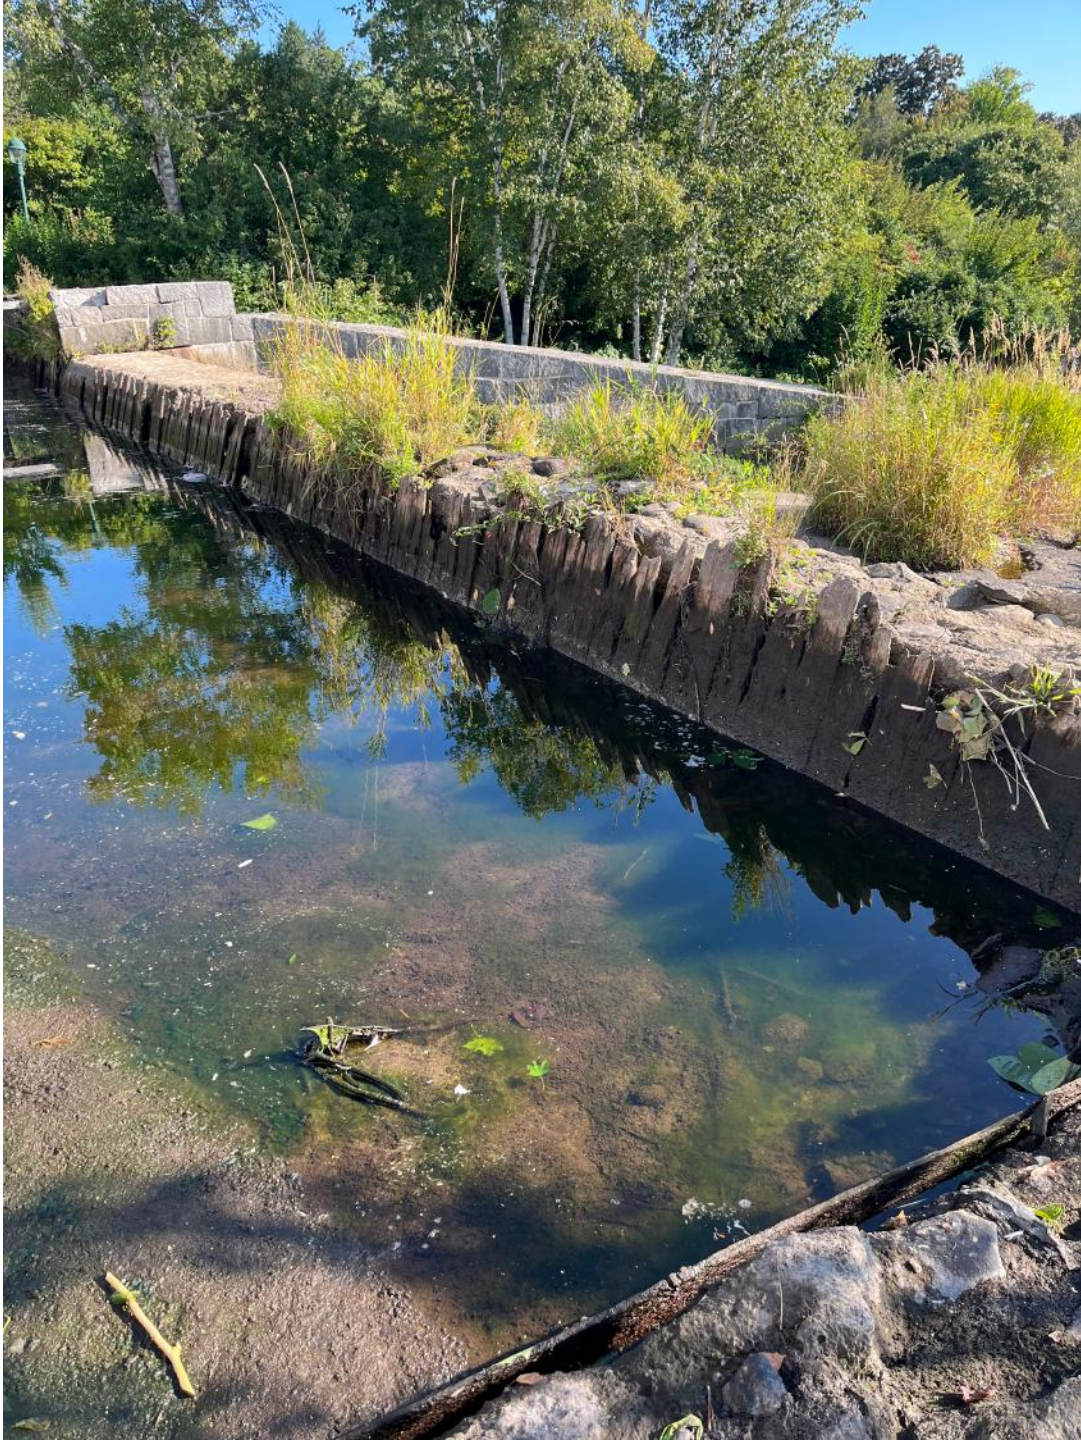
**Algal blooms in the millpond and grasses taking root in the dam spillway and bedrock. With the sluice gate open all summer, odors wafted up to our businesses and mosquitoes bred in the stagnant, drawn down pool. This is not the view we purchased with our buildings and businesses and not the promise we make to our customers. Photo taken: August 2022.**

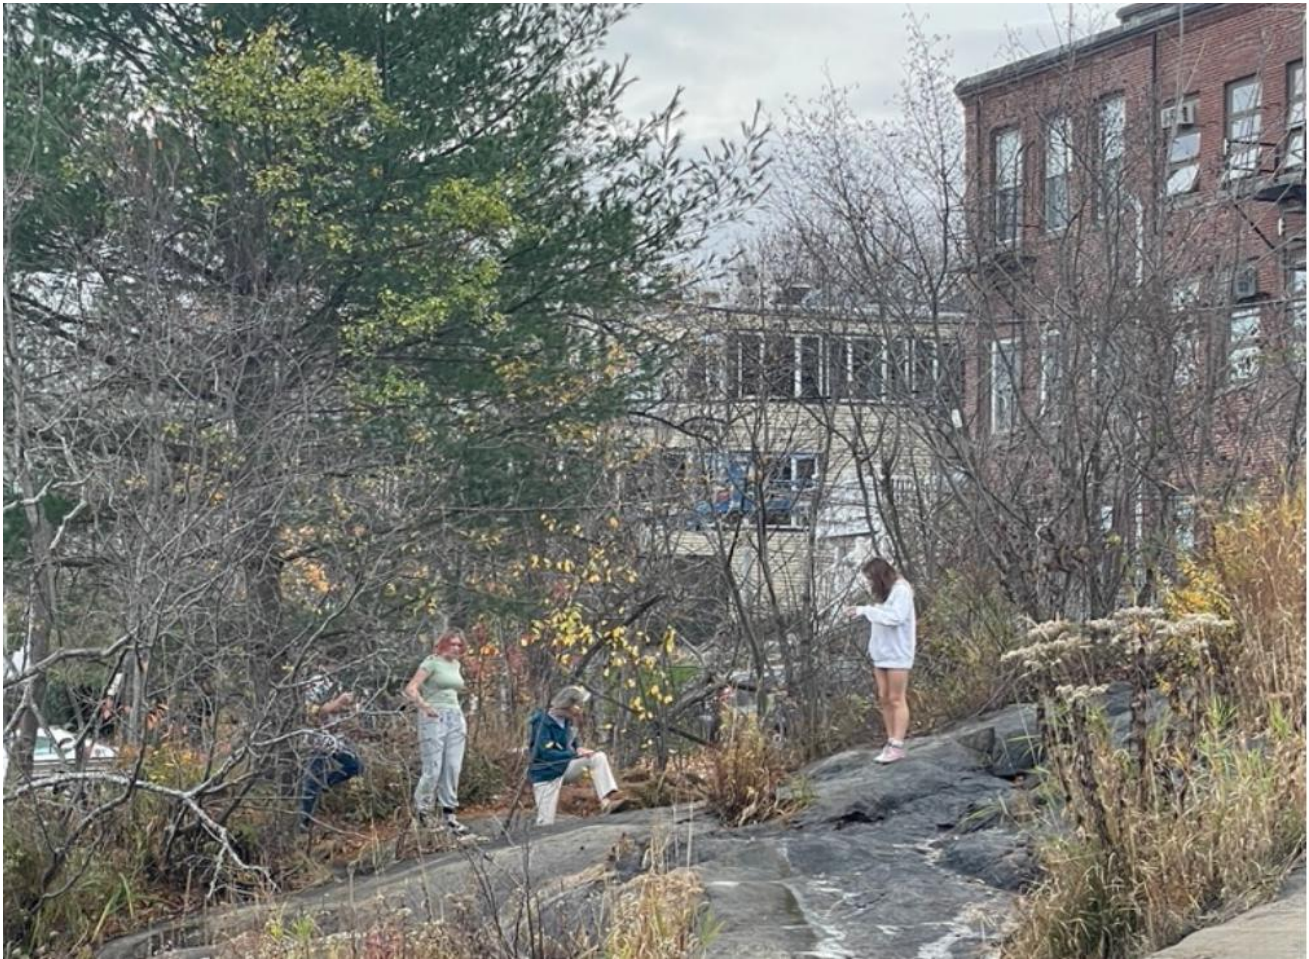
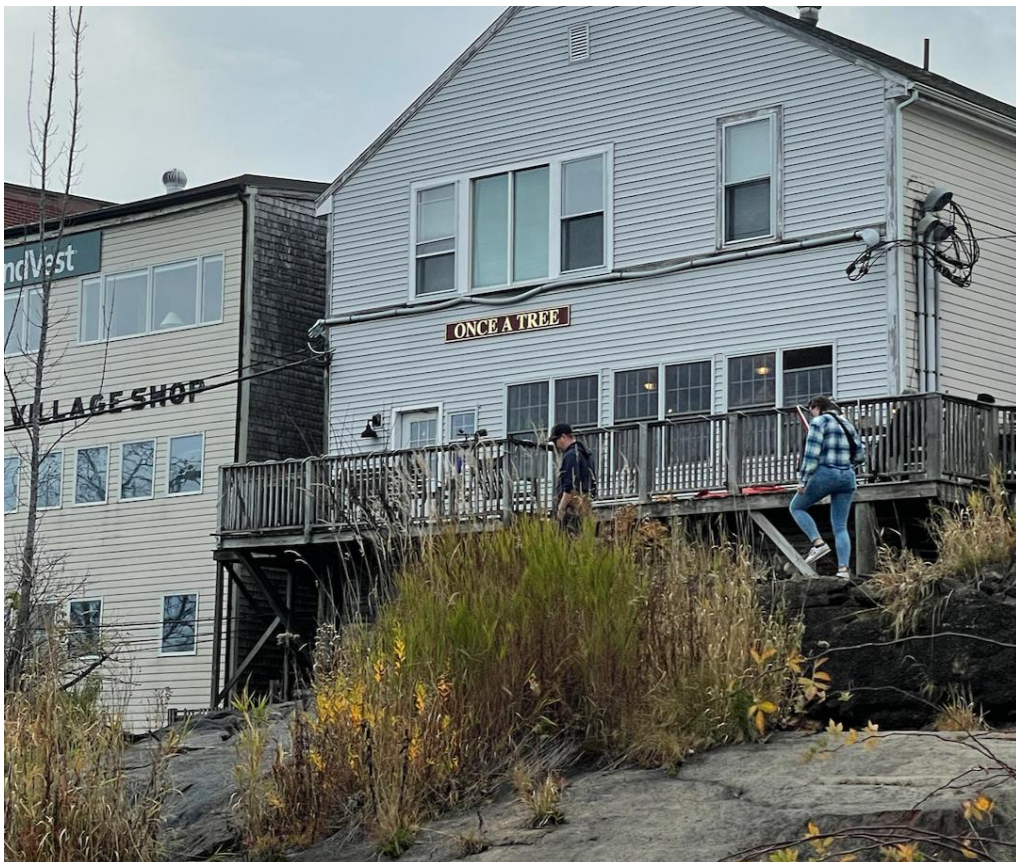
**Addendum F: Concerns over Risk showing people walking across the steep bedrock, drained millpond, and 2-foot wide dam spillway that overlooks the open sluice gate cavity, which is 50-feet long.**
